*Nemmadi.in*<sup>®</sup>

# HOME INSPECTION BOOKLET & REPORT

SAMPLE

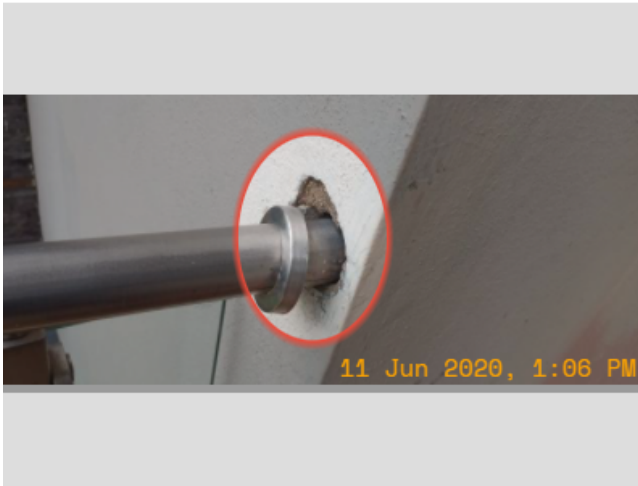
**82** BALCONY/DECK/STAIRCASE  
Are railings fixed properly?

Railing pipe to be fixed properly, as it is coming out of its position completely

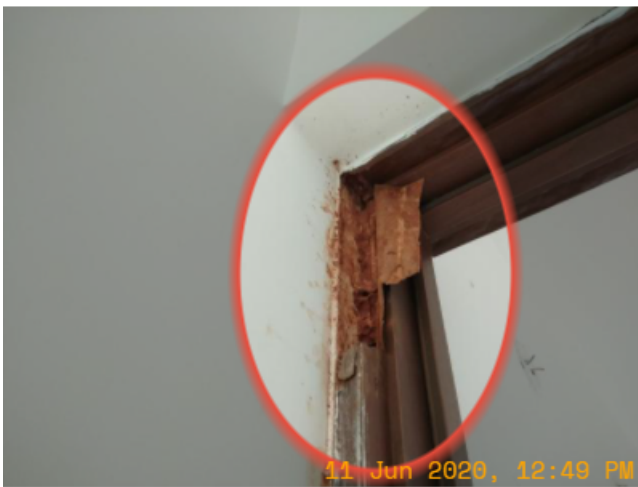
**110** DOOR FRAME  
Free from Termite attack?

Termite attack on door frame

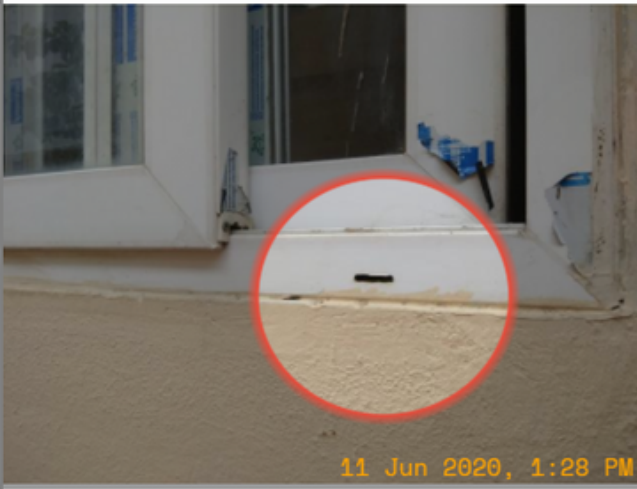
**143** WINDOWS / VENTILATOR (ALUMINIUM)  
Are the drain holes provided for bottom track?

Drain hole cap not provided

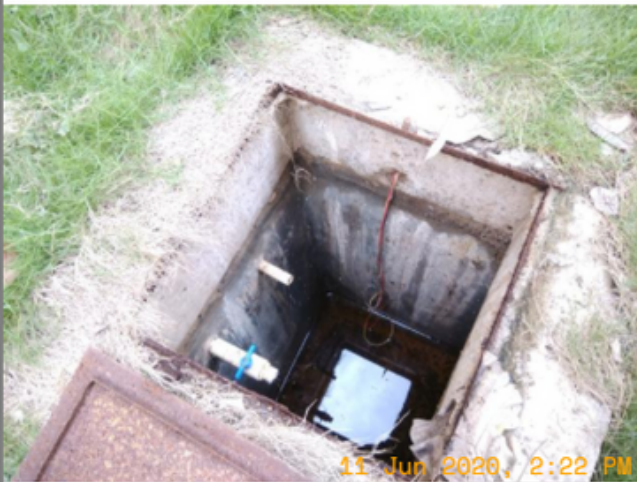
**2** UG SUMP  
Is ladder[rungs] provided for UG sump?

Rungs not provided inside for access

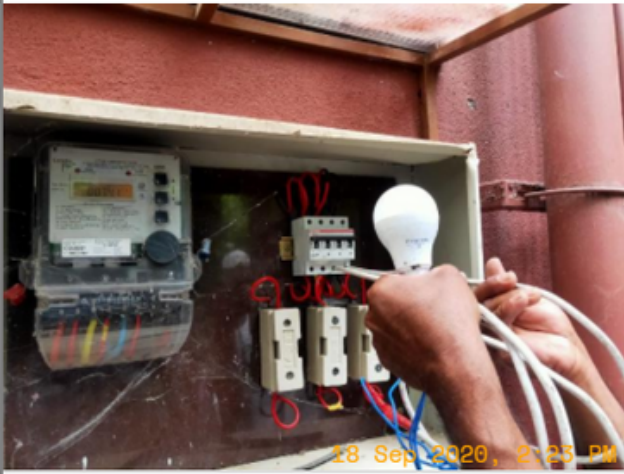
## 6 ELECTRICAL GENERAL Electrical

3 phase not working - external

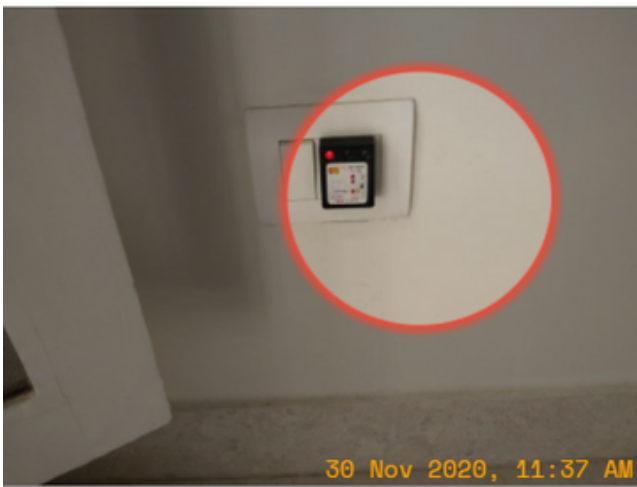
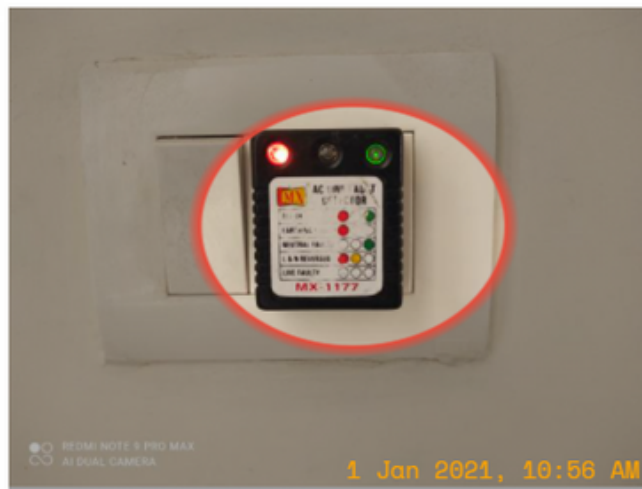
## 1 ELECTRICAL GENERAL Check earthing at all socket points

Earthing Faulty at wall no 3, all sockets

Rectified

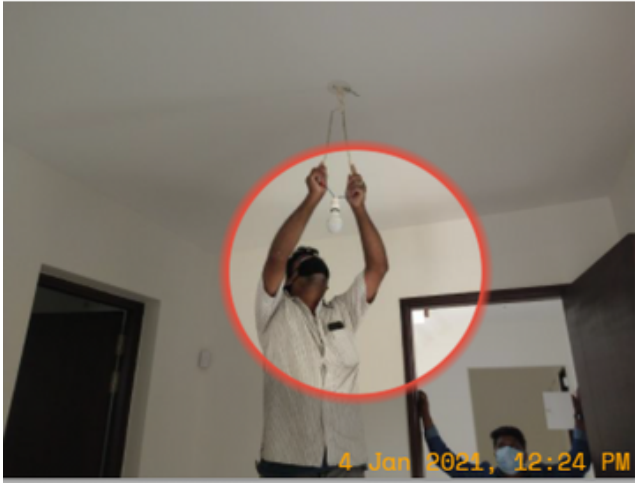
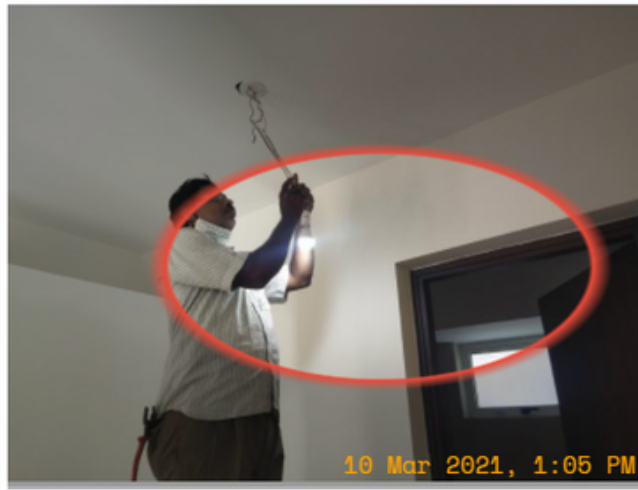
## 2 ELECTRICAL GENERAL Electrical

No power supply in ceiling point

Rectified

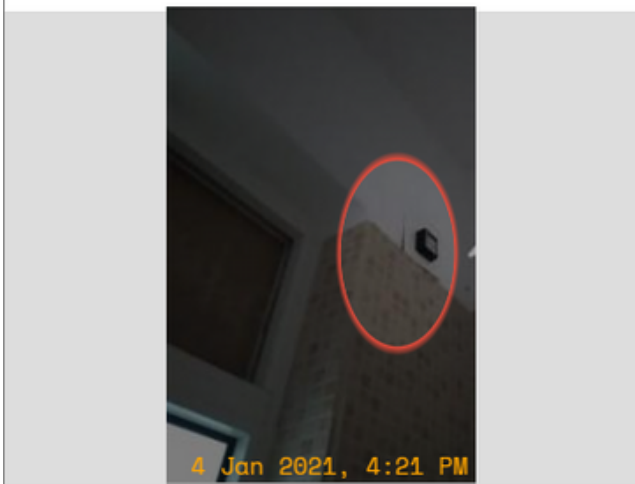
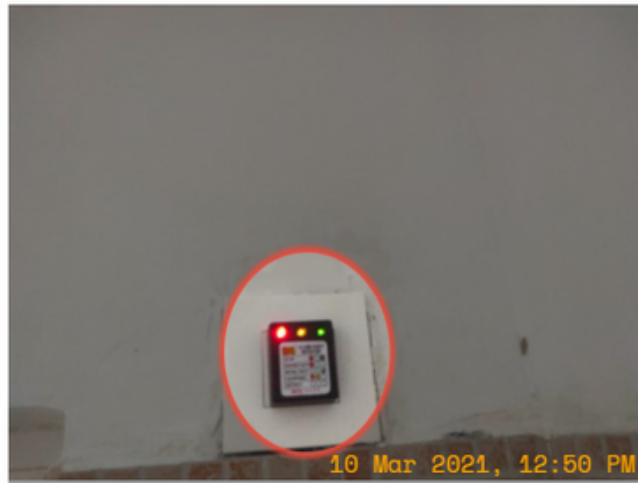
## 29 ELECTRICAL GENERAL Are all sockets/switches provided on phase/line?(not on neutral wire)

No power supply in wall no 1

Partially rectified line and neutral reverse

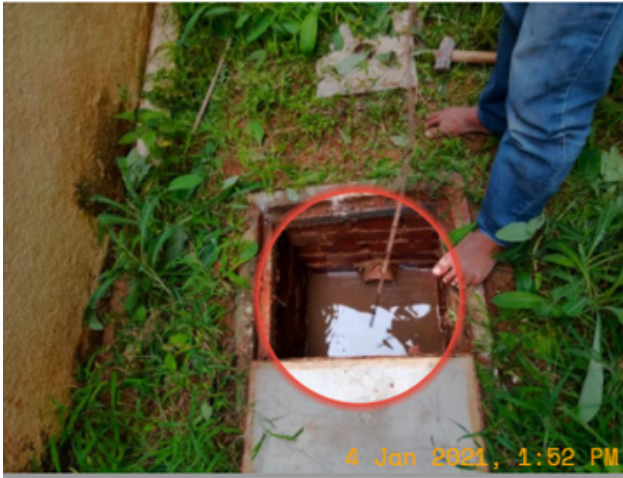
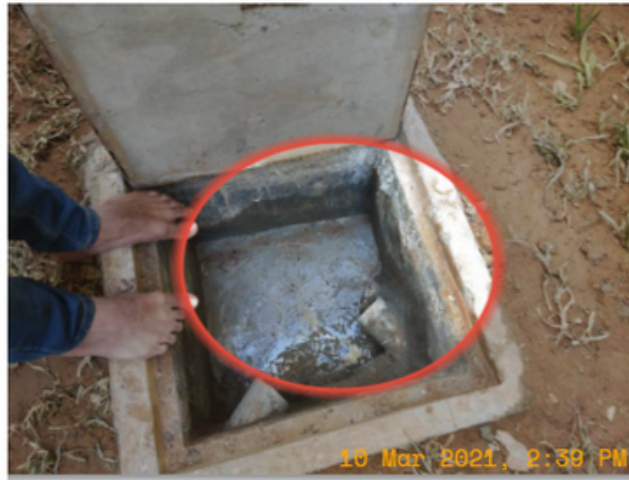
**5** EXTERNAL PIPELINE WORK  
Check external sanitary works by opening all manhole covers. [pour a bucket of water in toile

Blockage in inspection chamber (No free flow of water)

Rectified

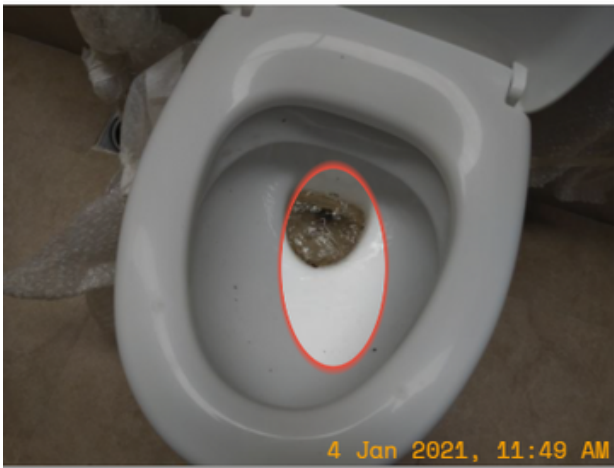
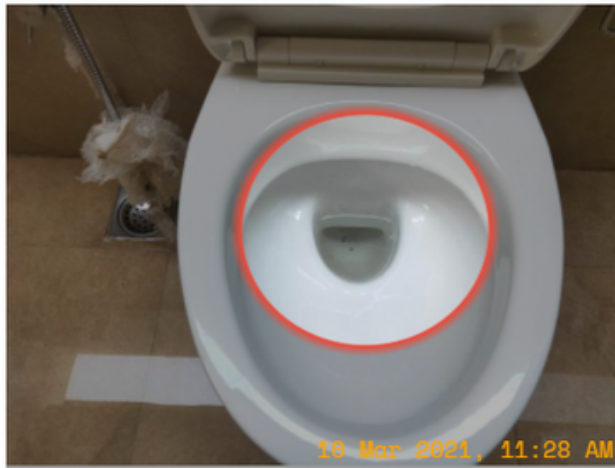
**15** PLUMBING  
Plumbing

Continuous water flow in EWC (leaking)

Rectified

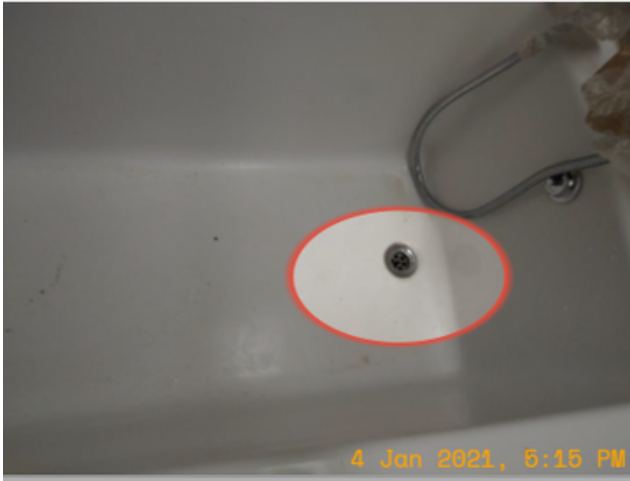
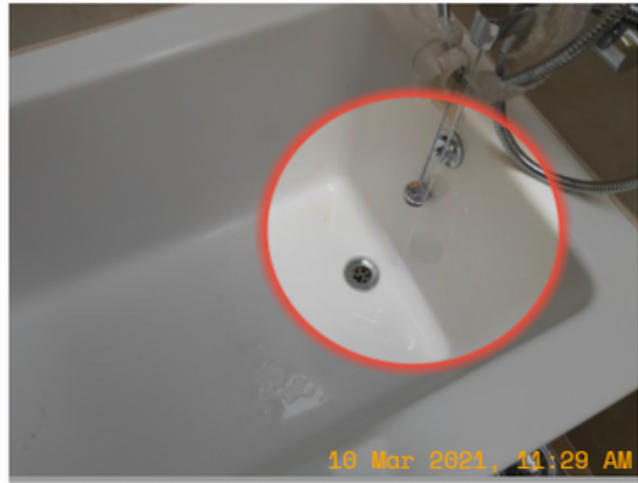
**16** PLUMBING  
Plumbing (3)

Drain plug not provided

Rectified

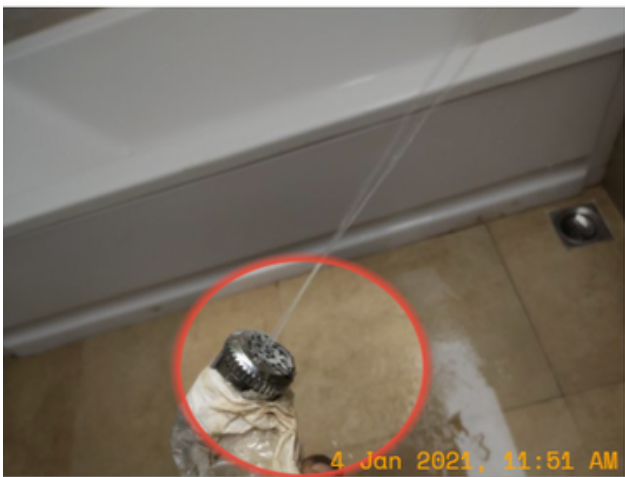
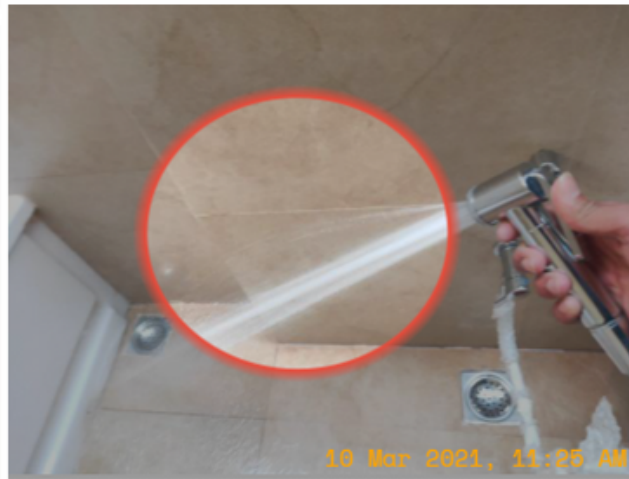
**17** PLUMBING  
Is the health faucet fixed completely (with pipe, gun and holder)? (2)

Health faucet gun holes blocked.

Rectified

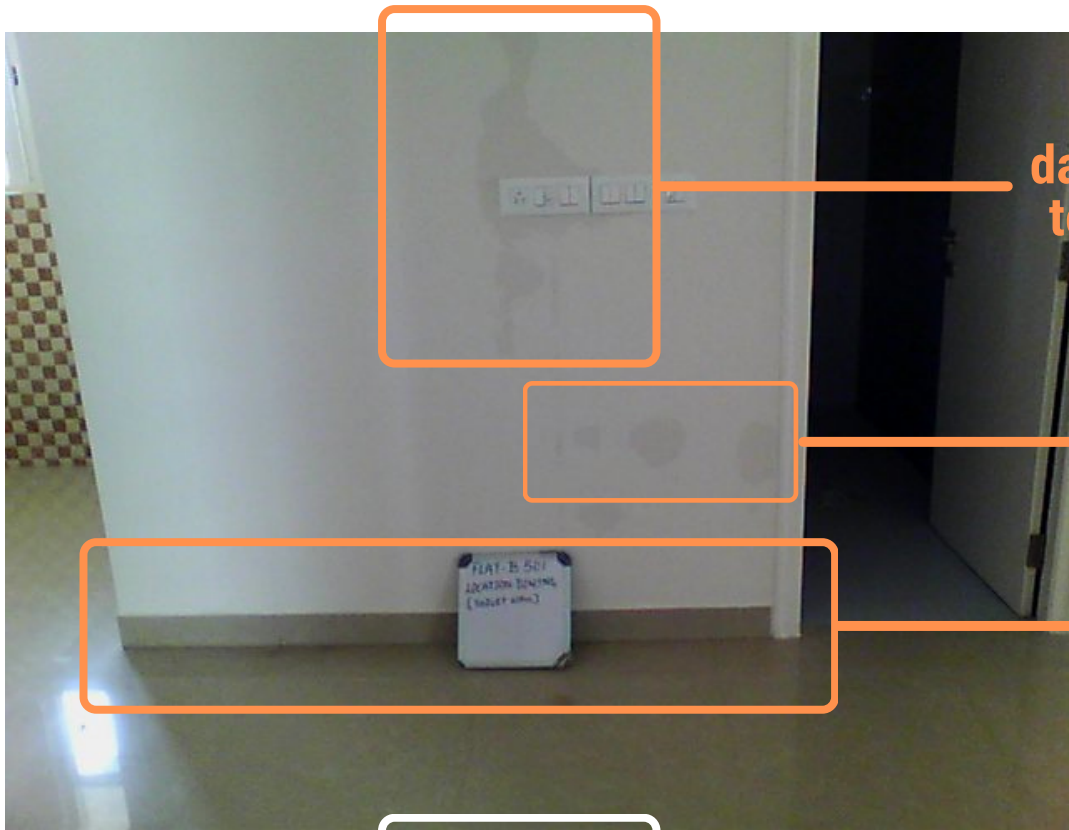
dampness visible to the naked eye

dampness NOT visible to the naked eye

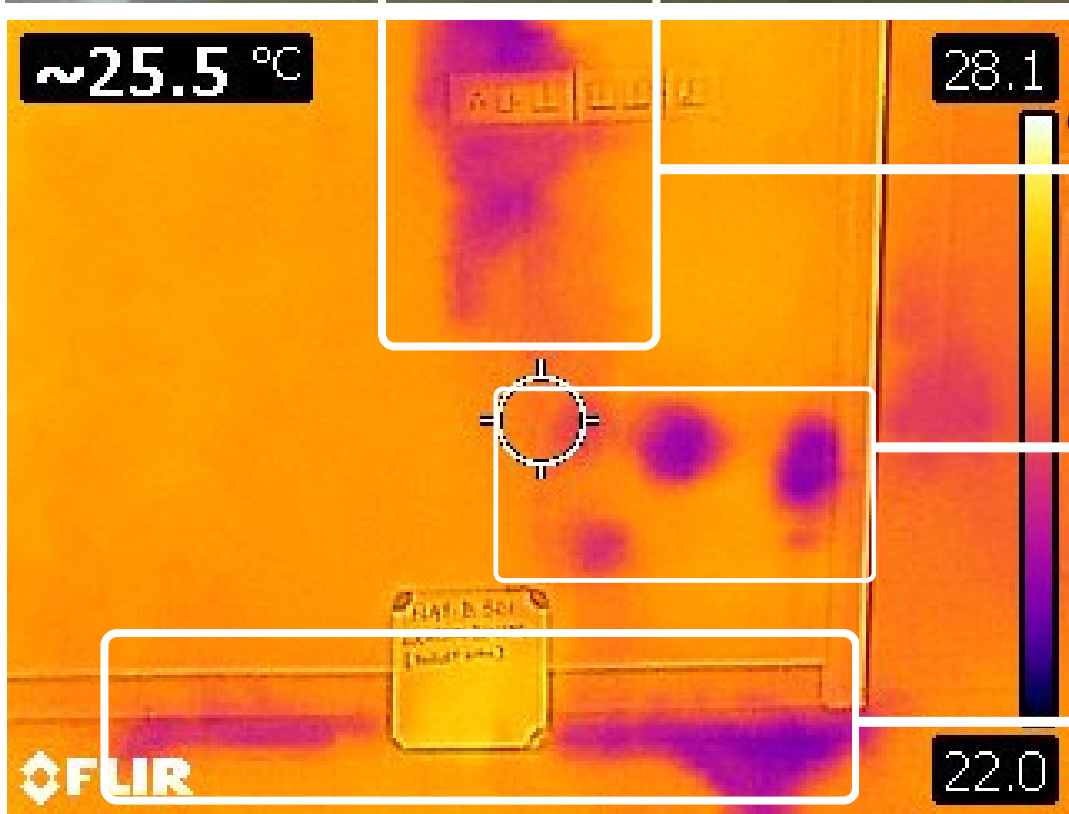
dampness visible as dark spots in Thermographic Camera

dampness NOT visible to the naked eye visible through IR
