Nemmadi.in[®]

HOME INSPECTION REPORT

SAMPLE

VISUAL REPORT

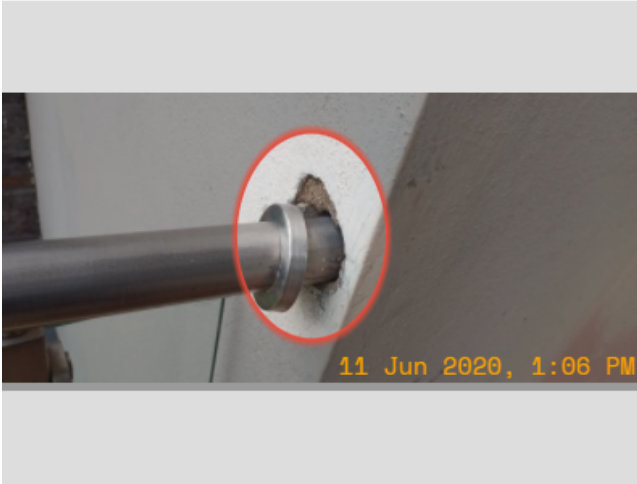
82 BALCONY/DECK/STAIRCASE
Are railings fixed properly?

Railing pipe to be fixed properly, as it is coming out of its position completely

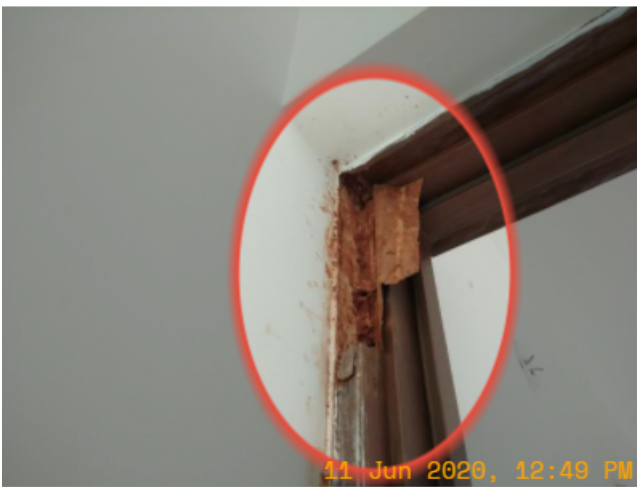
110 DOOR FRAME
Free from Termite attack?

Termite attack on door frame

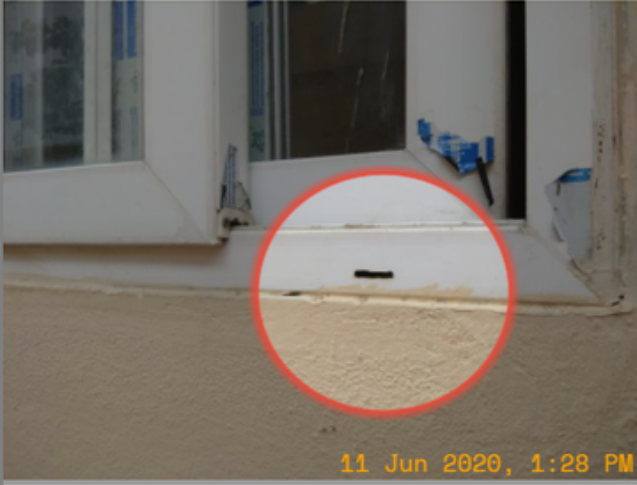
143 WINDOWS / VENTILATOR (ALUMINIUM)
Are the drain holes provided for bottom track?

Drain hole cap not provided

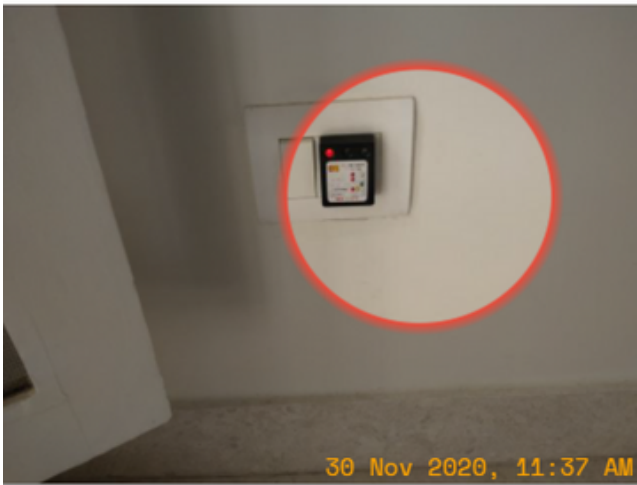
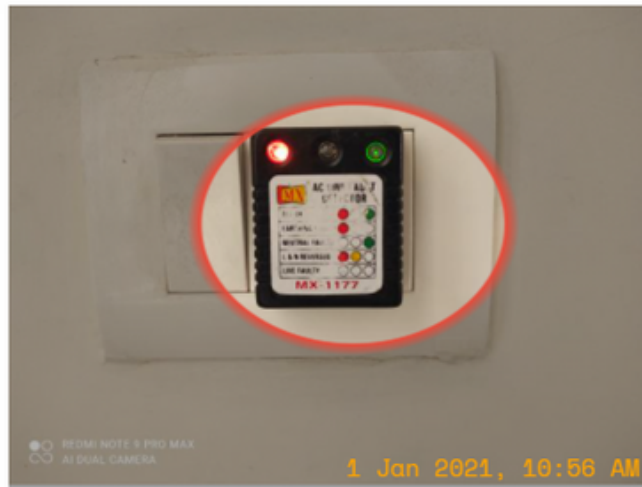
1 ELECTRICAL GENERAL Check earthing at all socket points

Earthing Faulty at wall no 3, all sockets

Rectified

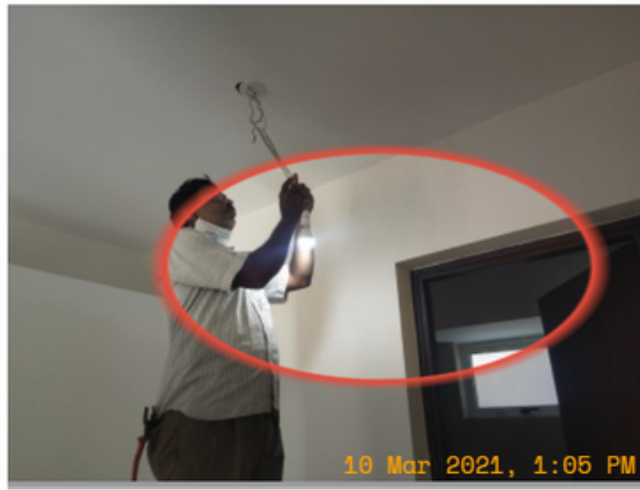
2 ELECTRICAL GENERAL Electrical

No power supply in ceiling point

Rectified

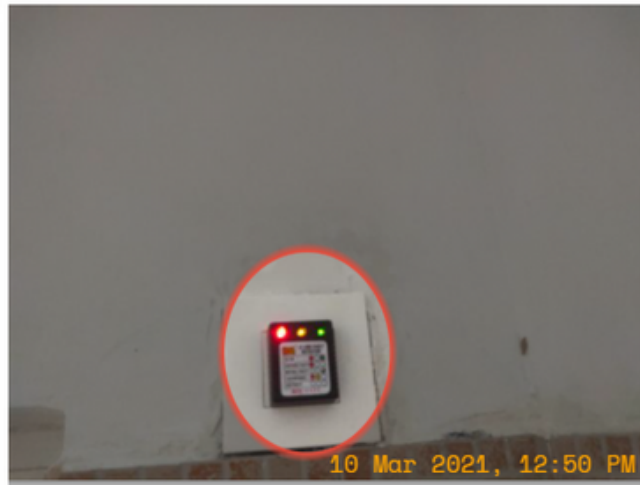
29 ELECTRICAL GENERAL Are all sockets/switches provided on phase/line?(not on neutral wire)

No power supply in wall no 1

Partially rectified line and neutral reverse

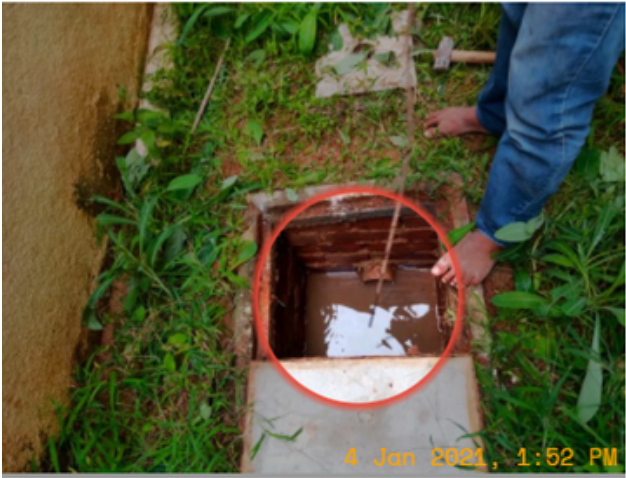
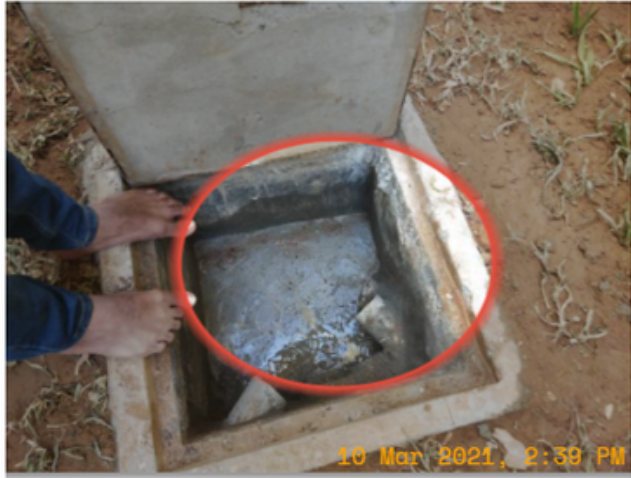
5 EXTERNAL PIPELINE WORK
Check external sanitary works by opening all manhole covers. [pour a bucket of water in toile

Blockage in inspection chamber (No free flow of water)

Rectified

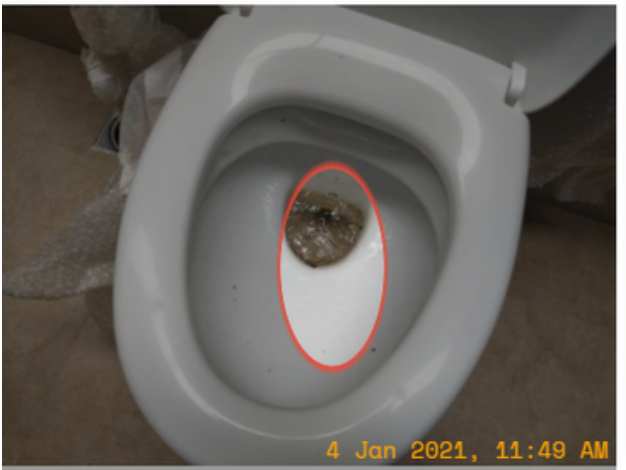
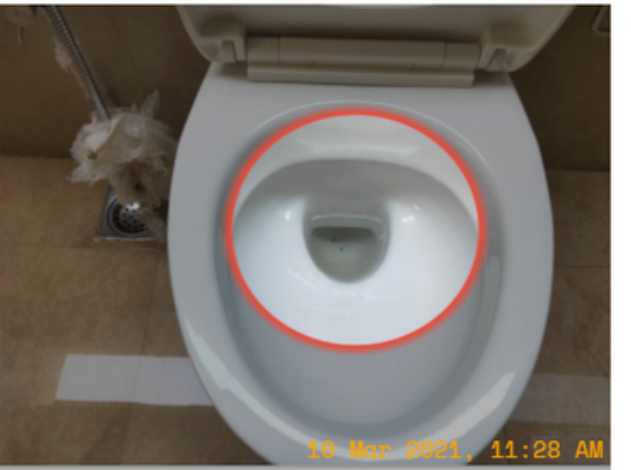
15 PLUMBING
Plumbing

Continuous water flow in EWC (leaking)

Rectified

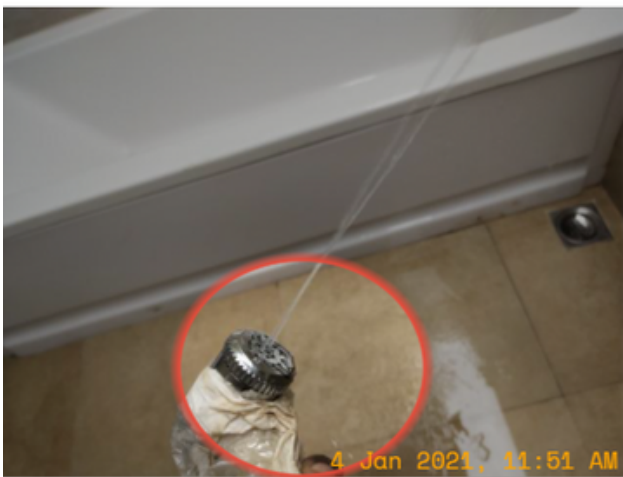
17 PLUMBING Is the health faucet fixed completely (with pipe, gun and holder)? (2)

Health faucet gun holes blocked.

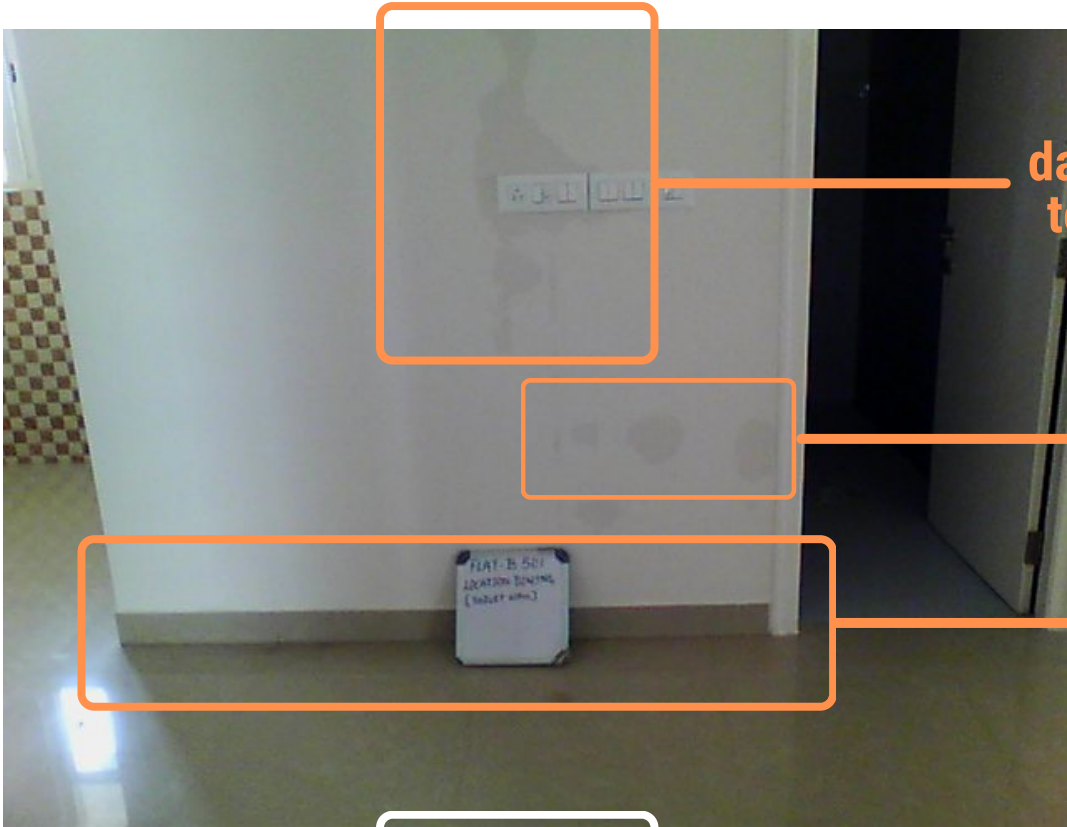
dampness visible to the naked eye

dampness NOT visible to the naked eye

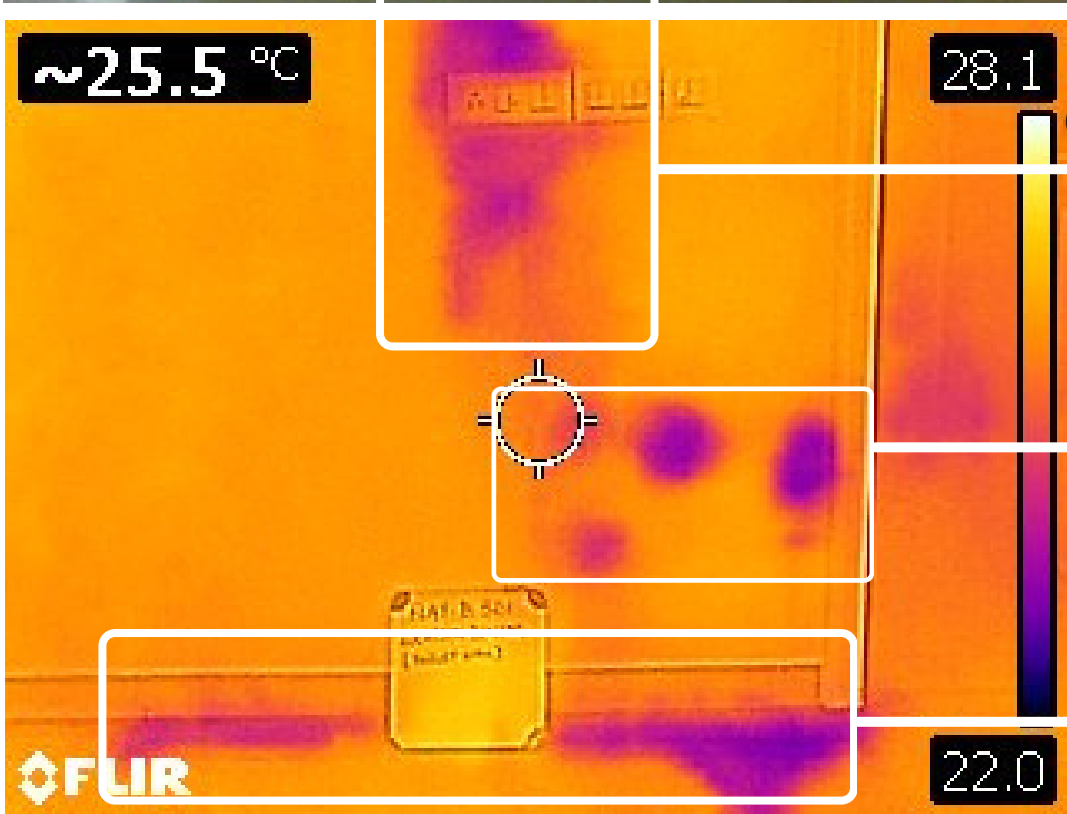
dampness visible as dark spots in Thermographic Camera

dampness NOT visible to the naked eye visible through IR
